# Manhole Inspection Summary

Manhole # S25E\_\_058MH

Insp Date: **7/24/08 3:54 PM**

**Location** Address: **227 CAREY ST**

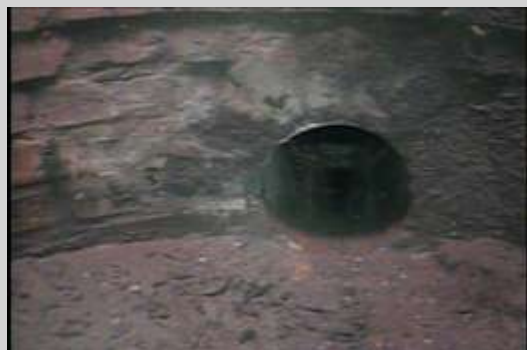
12 O'Clock Outflow

8 in. Circular Gravity Sewer  
Pipe Out @ 12 O'Clock

Pipe Height: **8.4** (in.) Rod and Bar (Angled)

Pipe Material: **Clay** ☐ Pipe Lined

Infiltration: **None** Pipe Seal Cond: **Sound**
